# CTIOA Technical Committee Technical Bulletin

Technical Bulletin  
No. 2010-3-23 Revision 0  
March 23, 2010  
Scale: None  
Page 1 of 7

## Tile Exterior Veneer Lath, Scratch, Brown Coat Tensile and Shear Bond Strength Testing Report

*A joint Study sponsored and conducted by CTIOA Technical Committee and Technical Services Information Bureau (representing the Lath, Plaster and Drywall for the Wall and Ceiling Industry)*

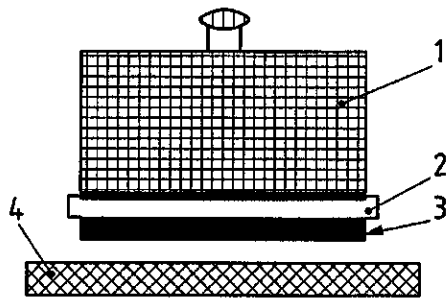
a) Adhesive failure between adhesive and substrate (AF-S)

Failure occurs at the interface between adhesive and substrate (AF-S) or between tile and adhesive (AF-T). The test value equals the adhesive strength [Figure 3 a) and b)]. In some cases the failure may occur in the adhesive layer between the tile and the pull head plate (BF) [Figure 3 c)]. In this case the adhesive strength is greater than the test value and the test should be repeated.

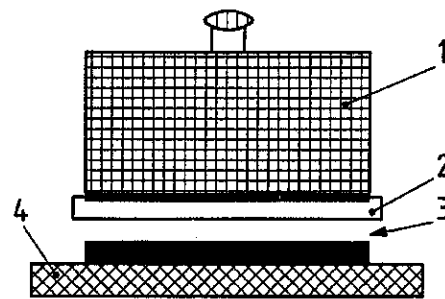
b) Adhesive failure between tile and adhesive (AF-T)

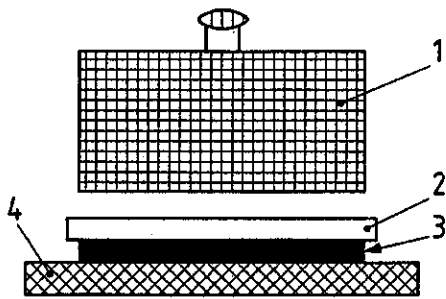
c) Adhesive failure between tile and pullhead plate (BF)

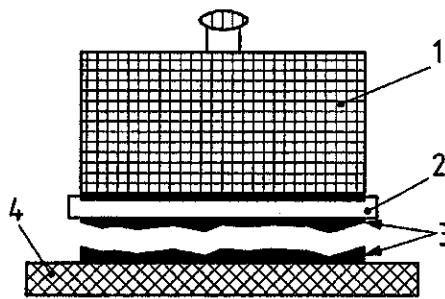
d) Cohesive failure within the adhesive (CF-A)

Failure occurs within the adhesive layer [Figure 3 d)].

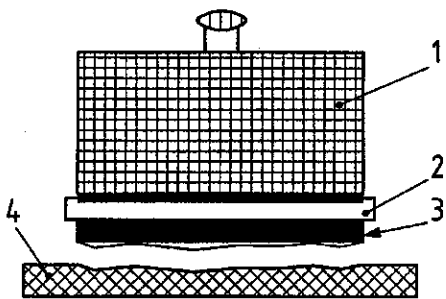
e) Cohesive failure within the substrate (CF-S)

The failure occurs within the substrate (CF-S) [Figure 3 e)] or within the body of the tile (CF-T) [Figure 3 f)]. In this case, the strength of the adhesive is greater than the test value.

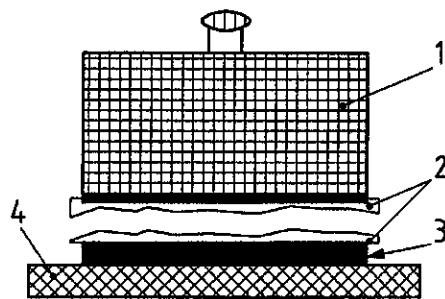
f) Cohesive failure within the tile (CF-T)
